Navajo Abandoned Uranium Mine

Site Screen Report

Mine Name: Charles Huskon No. 1
Mine ID: 124

August 2011

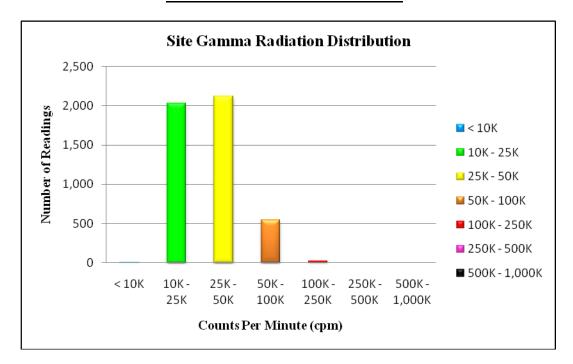
Highest gamma radiation measurement: 164,291 counts per minute (cpm)

Background Average: 17,549 cpm **Two Times Background:** 35,098 cpm

A total of 4,730 gamma radiation measurements were collected from the mine site, ranging from 8,377 cpm to 164,291 cpm. Measurements collected in the vicinity of the reclamation area were found at a maximum level of approximately 160,000 cpm. The measurements are represented in Figures 1 and 2.
